Manhole Inspection Summary

Manhole # S45G2_019MH

Insp Date: **1/3/08 11:00 AM**

Location Address: **1432 Locust St** Cross Street: **Fairhaven Ave.**

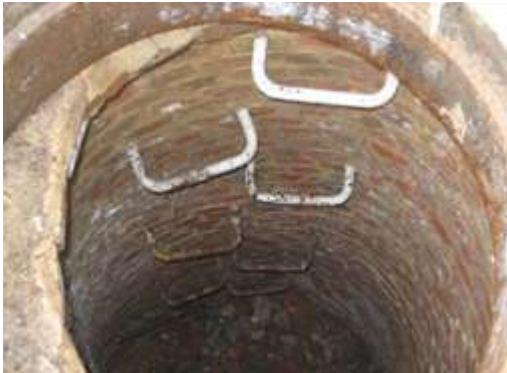
Steps Count: **7** Missing: **0** ☐ Corroded

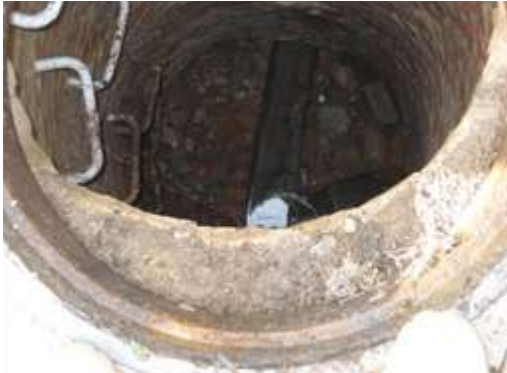
Defect 1

Frame Offset: **3** (in.) Condition: ☒ Sound ☐ Cracked ☐ Leaks

Frame offset

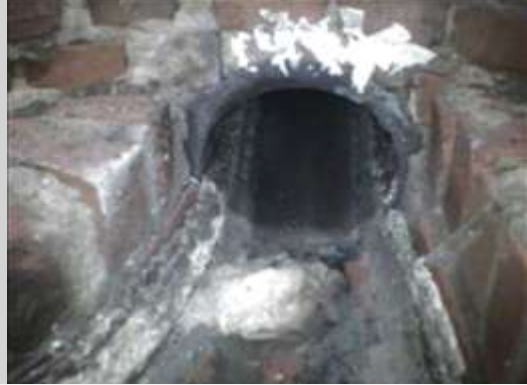
12 O'Clock Outflow

8 in. Circular Gravity Sewer
Pipe Out @ 12 O'Clock

Pipe Height: **9.6** (in.) Rod and Bar (Angled)
Pipe Material: **Clay** ☐ Pipe Lined
Invert Depth: **12.07** (ft.) Flow Characteristics: **Fast**
Deposits: ☒ None ☐ Mud ☐ Sludge ☐ **Debris** ☐ Grease
Silt Depth: (in.) Deposits Extent:
Infiltration: **None** Pipe Seal Cond: **Sound**

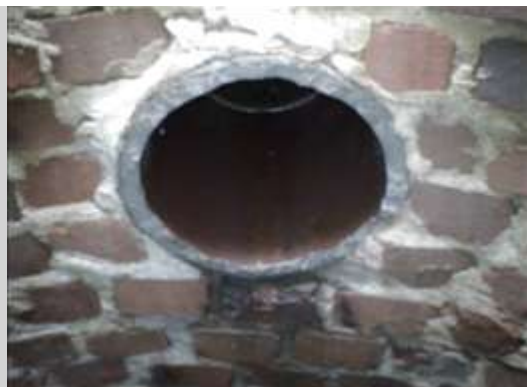
6 O'Clock Inflow

8 in. Circular Gravity Sewer
Pipe In @ 6 O'Clock

Pipe Height: **9.6** (in.) Rod and Bar (Angled)
Pipe Material: **Clay** ☐ Pipe Lined
Invert Depth: **8.71** (ft.) Flow Characteristics: **Fast**
Deposits: ☒ None ☐ Mud ☐ Sludge ☐ **Debris** ☐ Grease
Silt Depth: (in.) Deposits Extent:
Infiltration: **None** Pipe Seal Cond: **Sound**

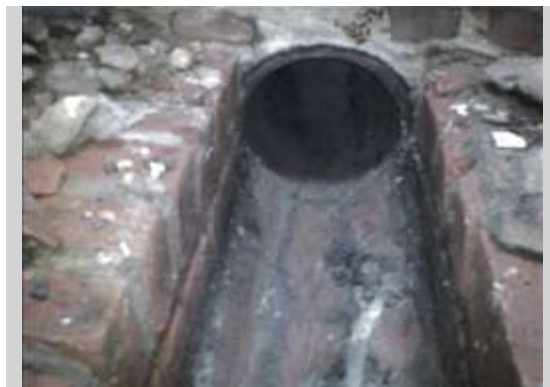
Drop In @ 6 O'Clock

Drop: **Outside** **Rod and Bar**
Angled: **Yes** Reading: **11.09** (ft.)
Inv Depth: **12.09** (ft.)
Drop Condition: **Open**

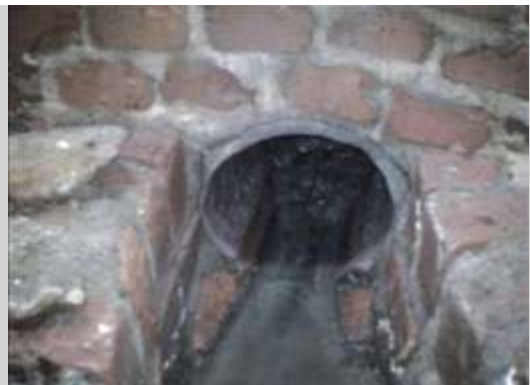
9 O'Clock Inflow

Pipe In @ 9 O'Clock

Invert Depth: **11.97** (ft.) Flow Characteristics: **None**

Deposits: ☐ None ☐ Mud ☐ Sludge ☒ **Debris** ☐ Grease

Silt Depth: **0** (in.) Deposits Extent: **Light**
